AT1A-3463-1

AccuTemp Products, Inc 8415 N. Clinton Park Fort Wayne, IN 46825	<b>C</b>	<b>AT1A-3463</b>	<b>A</b>
				Material:			5/1/2008

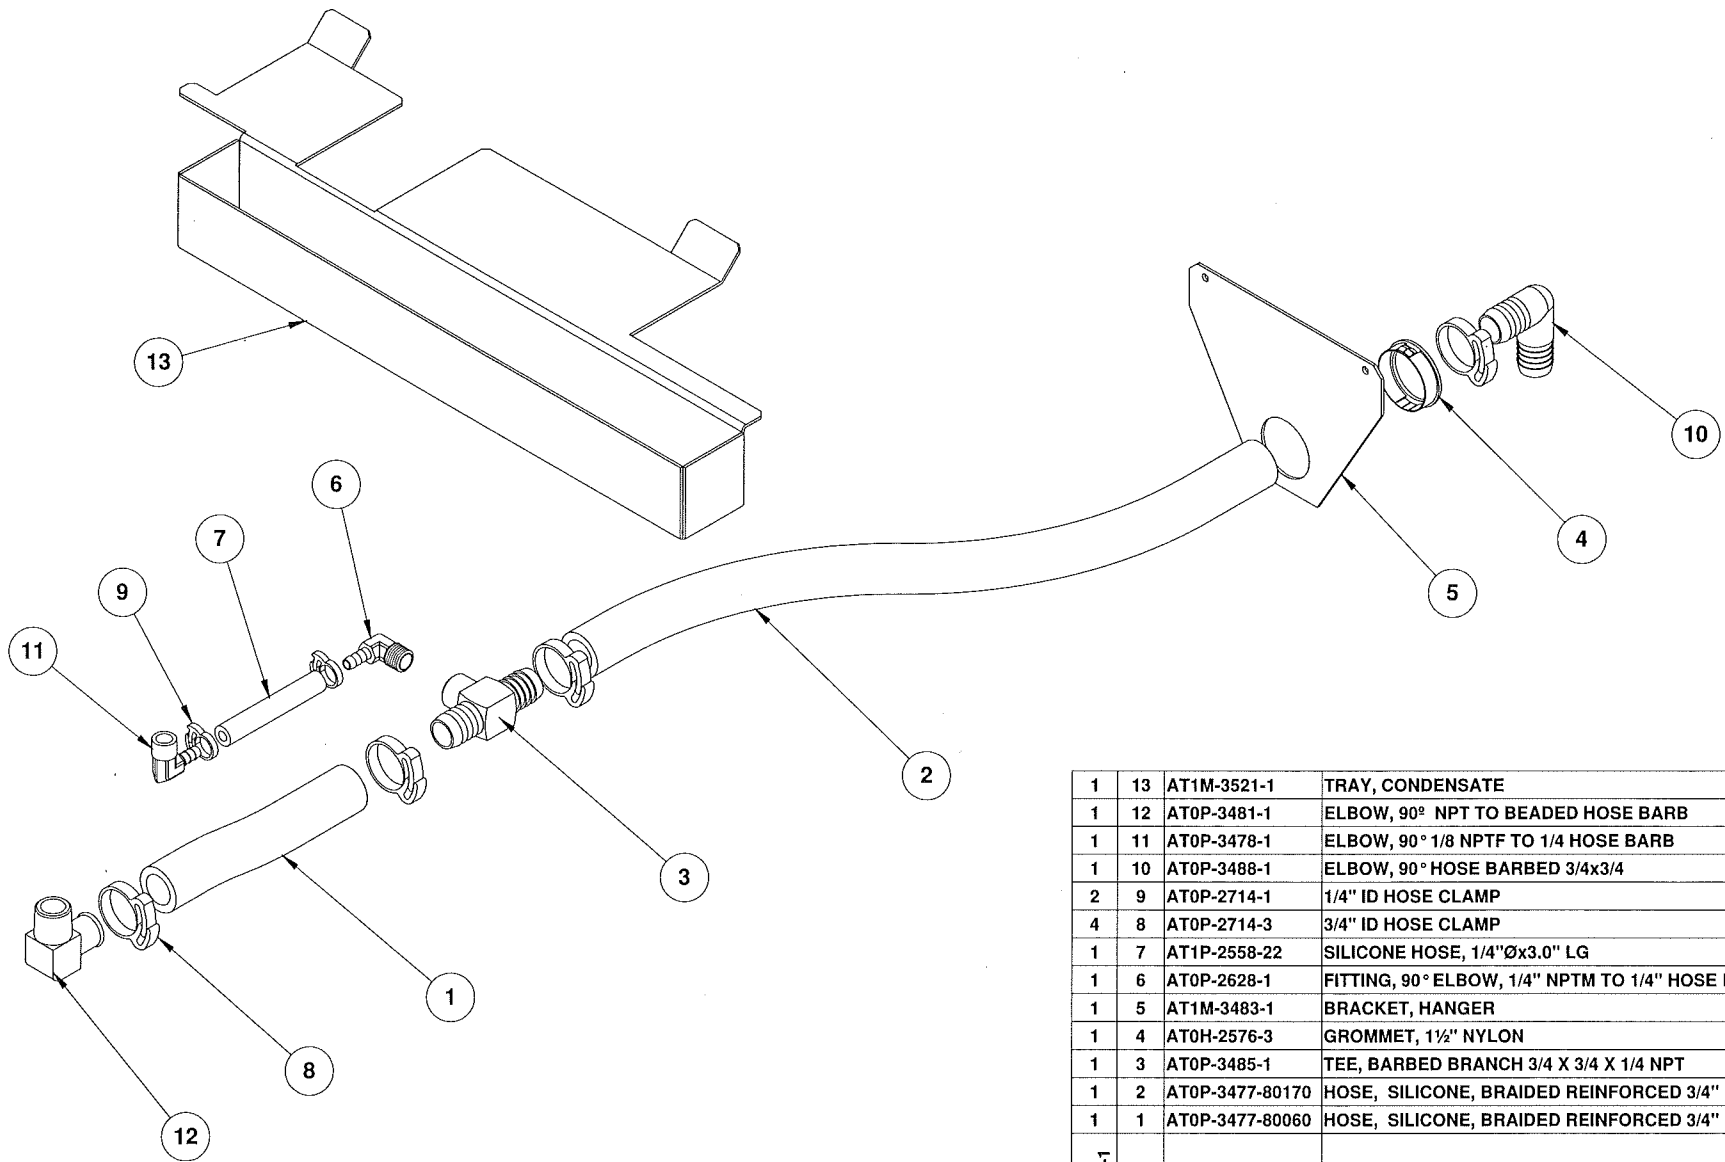
Bottom View of Drain Assembly

1	13	AT1M-3521-1	TRAY, CONDENSATE
1	12	AT0P-3481-1	ELBOW, 90° NPT TO BEADED HOSE BARB
1	11	AT0P-3478-1	ELBOW, 90° 1/8 NPTF TO 1/4 HOSE BARB
1	10	AT0P-3488-1	ELBOW, 90° HOSE BARBED 3/4x3/4
2	9	AT0P-2714-1	1/4" ID HOSE CLAMP
4	8	AT0P-2714-3	3/4" ID HOSE CLAMP
1	7	AT1P-2558-22	SILICONE HOSE, 1/4"Øx3.0" LG
1	6	AT0P-2628-1	FITTING, 90° ELBOW, 1/4" NPTM TO 1/4" HOSE BARB
1	5	AT1M-3483-1	BRACKET, HANGER
1	4	AT0H-2576-3	GROMMET, 1½" NYLON
1	3	AT0P-3485-1	TEE, BARBED BRANCH 3/4 X 3/4 X 1/4 NPT
1	2	AT0P-3477-80170	HOSE, SILICONE, BRAIDED REINFORCED 3/4" IDx17" LG
1	1	AT0P-3477-80060	HOSE, SILICONE, BRAIDED REINFORCED 3/4" IDx6" LG

A black and white photograph showing the bottom view of a drain assembly. A white manual drain handle is located at the top left. A dark, flexible drain hose is connected to a white plastic fitting on the right side. The assembly is mounted on a metal panel with a vent grille on the left. A white arrow points to the manual drain handle, and another white arrow points to the drain connection fitting. The background is a dark, textured surface.

Manual Drain Handle

Drain Connection  
(fitting not shown)
